PHOTOGRAPHIC INTERPRETATION REPORT

SUMMARY OF ACTIVITY IN CUBA

NPIC/R-65/66 FEBRUARY 1966

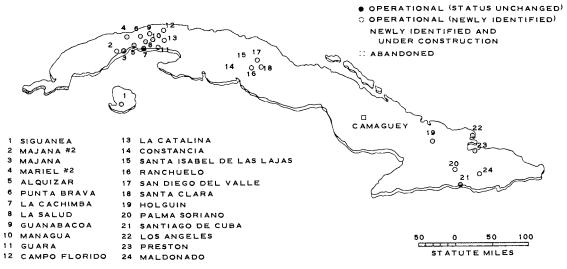
FIGURE 1. CURRENT SA-2 SITE DEVELOPMENT.

This raises the total of deployed operational SAM sites in Cuba to 22 with 2 additional sites (1 of which is a possible) remaining under construction (Figure 1).

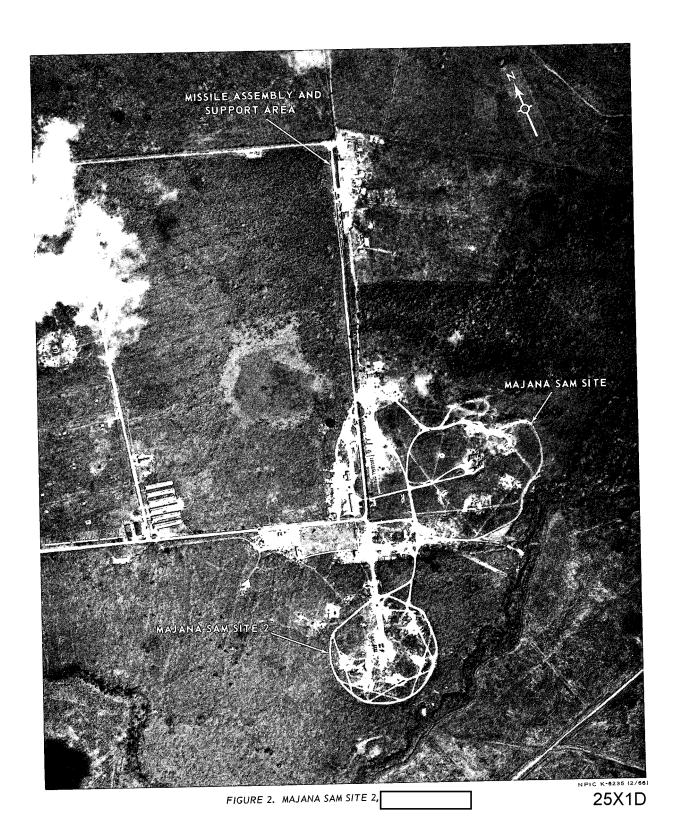
Majana SAM Site 2 (Figure 2). This site, 0.2 nm southwest of Majana SAM Site, was newly identified on ______.

Due to the close proximity of the main site and

the unusual activity at the site, it is probably used as a training site.

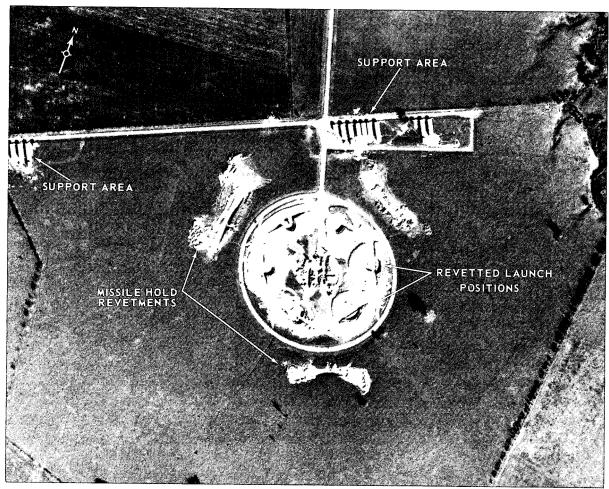
FIGURE 3. SANTA ISABEL DE LAS LAJAS SAM SITE, DE 25X1D

Santa Isabel De Las Lajas SAM Site (Figure 3). Small ground scars were visible in the main support area on _______ An access road to the support areas was observed on _______ In addition, foundations for 1 small and 4 large buildings were noted. Two concentric circles, approximately 750 feet and 125 feet in diameter, were faintly discernible.

The installation was identified as a probable SA-2 SAM Site under construction on

slowly. On the site was confirmed to be in mid-stages of construction, consisting of 6 launch revetments (1 in early stages of being revetted), 3 hold revetments in early stages of construction, and an unrevetted central guidance area. The outer ring road was completed and surfaced. The 6 inner service roads were not yet surfaced. Support facilities consisted of 7 probable barracks and 4 large and 6 small support buildings. A few miscellaneous vehicles were observed.

To date, the site is not operational. No

missile-associated vehicles or pieces of equipment were observed during this reporting period.

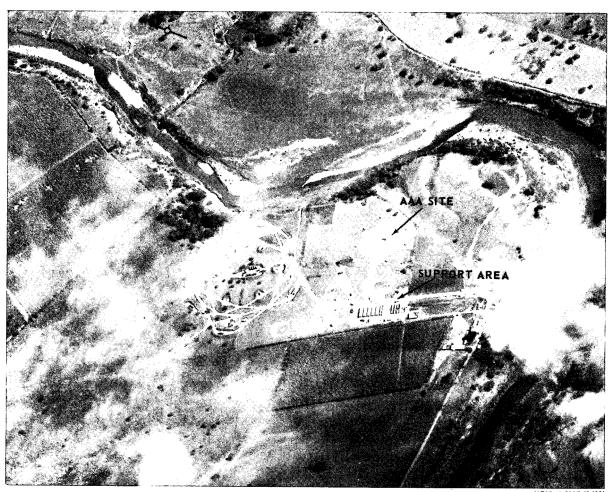
FIGURE 4. PALMA SORIANO SAM SITE,

Palma Soriano SAM Site (Figure 4). This site was newly identified in mid-to-late stages of construction on The site was unoccupied. However, SA-2 launchers, missile transporters, and associated pieces of equipment were observed in the area. The site was completed and operational on

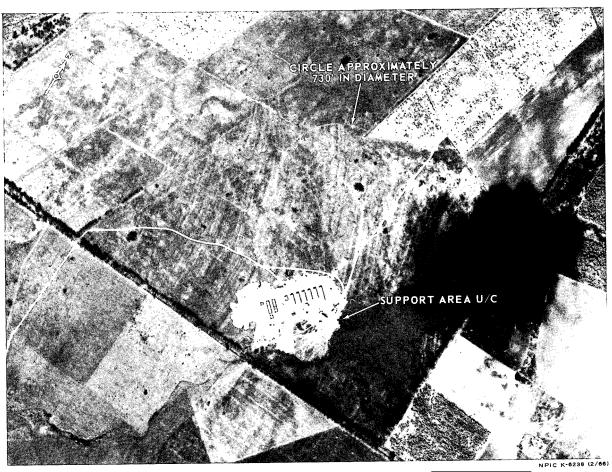
FIGURE 5. CONSTANCIA POSSIBLE SAM SITE UNDER CONSTRUCTION,

Constancia SAM Site (Figure 5). location was initially reported as a possible SA-2 site under construction on

5 probable barracks and 2 large and 3 small support buildings were completed, and 2 large and 3 small support buildings were under construction. No missile-associated vehicles or pieces of equipment were observed. To date, the site remains unconfirmed.

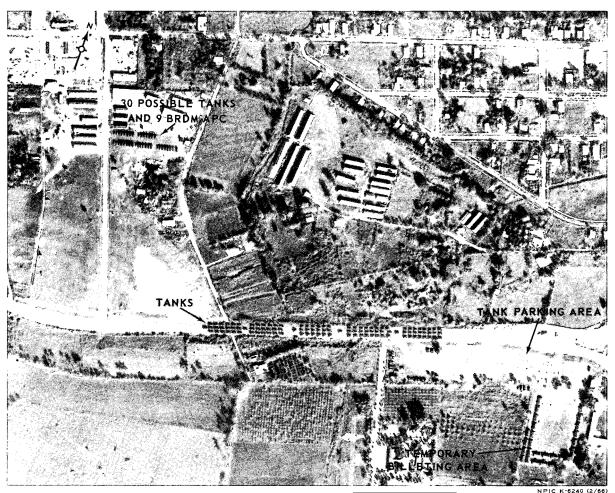
FIGURE 7. PARCELACION MODERNA,

graphic coverage. Also, at this location, on 104 tanks/SP guns, 37 probable BTR 60-P, 20 cargo trucks, and 31 other vehicles were observed on clear photographic coverage. In addion, 250 personnel in formation were observed.
